Chasing a Latent CDM ESD Failure by Unconventional FA Methodology

Abstract – A hard-to-detect functional CDM ESD failure caused by an obscure charge trapping phenomenon on an advanced CMOS IC is described while no physical damage was evident. Advancing failure analysis method by localized thermal LASER annealing and applying analytical ESD test plan led to successful localization of the root cause.

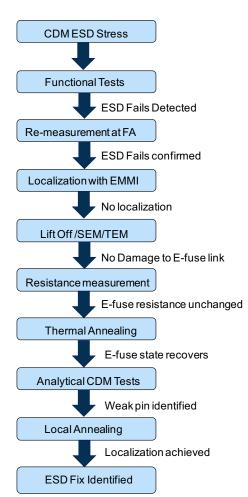
Figure 12: Applied Test and FA methods and their outcomes.

A brief summary of the applied test and FA flow and the result from each step is indicated in the Fig. 12.
