Latent Damage and Reliability in Semiconductor Devices

PROJECT PLAN V1

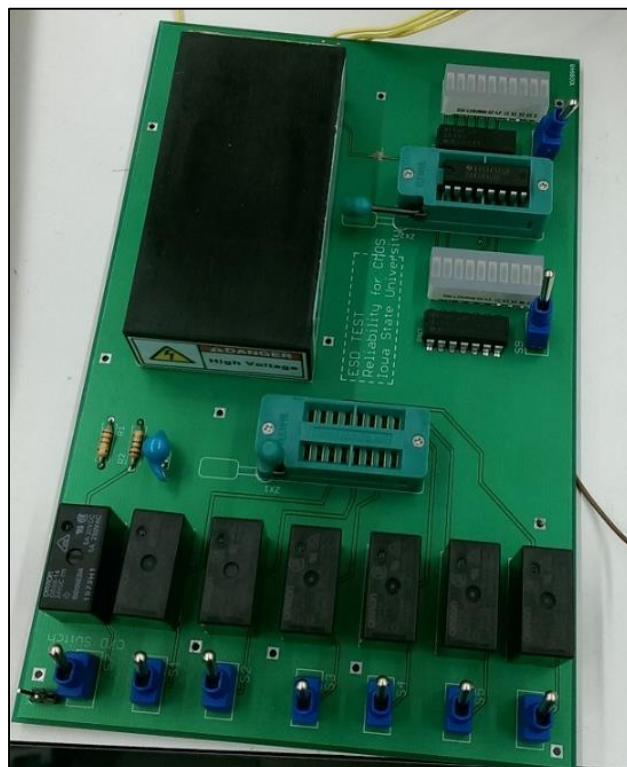
Figure 2: ESD Stress PCB

The ESD Stress PCB is designed to charge a capacitor (*Figure 2*), via a high-voltage source, and then by flipping a switch, discharge that capacitor to the Device under Test (DUT). This will allow us to simulate an ESD event on a device. Currently, the high-voltage source on the existing board is non-functional due to a previous experiment. Our plan, as of now, is to use an electric fencer charging system as a cheap alternative to the high-voltage source.

The first part of our experiment will involve taking a sample of 100 parts, subjecting them to a high-voltage ESD event, using the PCB as described in Section 4.2.1 of this document. A capacitor will be charged with a high-voltage source, then discharged into a single input of each COTS part.
