# Latent Damage and Reliability in Semiconductor Devices

PROJECT PLAN

Advisor & Client: Dr. Randall Geiger, ECpE

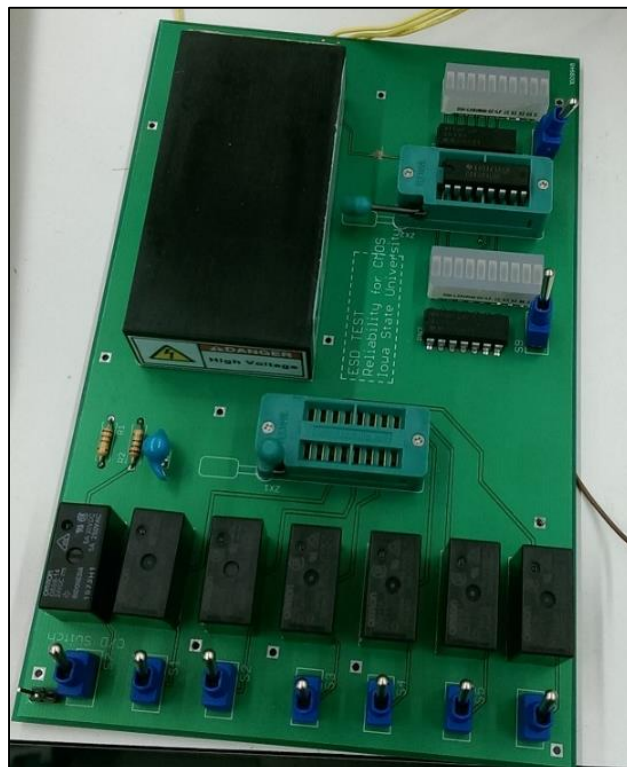
Figure 2: ESD Stress PCB

The ESD Stress PCB is designed to charge a capacitor (*Figure 2*), via a high-voltage source, and then by flipping a switch, discharge that capacitor to the Device under Test (DUT). This will allow us to simulate an ESD event on a device. Currently, the high-voltage source on the existing board is non-functional due to a previous experiment. Our plan is to use a standalone high-voltage source as an alternative.

The first part of our experiment will involve taking a sample of 100 COTS devices and subjecting them to a high-voltage ESD event. This procedure will use the PCB described in Section 4.2.1. A capacitor will be charged with a high-voltage source, then discharged into the input gate of a hex inverter. This procedure is ESD stress procedure is repeated for each hex inverter of all 100 COTS devices.

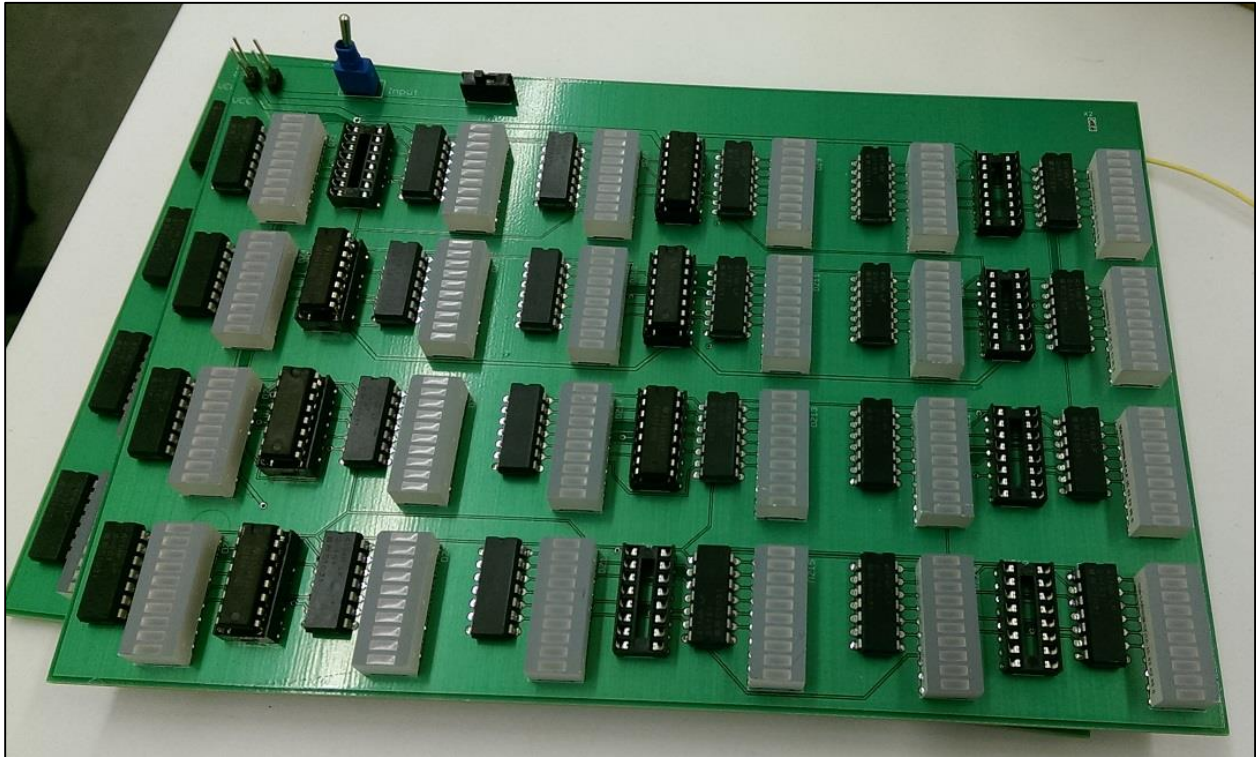
Figure 3: DUT burn-in PCB

The DUT burn-in PCB (*Figure 3*) is used to monitor multiple devices while accelerating their lifetime in a burn-in oven. It has a set of LED arrays which provide output levels of the devices as well as a control switch to vary the input level of the devices.

Our metric for determining failure of the device during burn-in will be through the logic levels. As each device contains multiple inverters, the status of the LED indicators on the DUT burn-in PCB should be opposite that of the shared input of the testing board. A failure will be considered when any of the inverters on a device have incorrect logic.
