ESD Induced Latent Defects In CMOS ICs And Reliability Impact

Abstract – A dedicated test vehicle was designed to study the impact of ESD induced latent defects on digital and analog CMOS circuits. Both CDM and TLP stresses were applied to these circuits through a specific pad which allows stressing the circuit core. Both electrical characterization and non-destructive failure analysis were performed to locate the induced defect. For digital circuits, functionality is not affected although the IDDQ quiescent current increased. However, after burn-in and storage, it was observed that the IDDQ current significantly increased suggesting that the circuit lifetime is degraded. In contrast, even at very low stress level, the analog circuit exhibits a dramatic offset degradation and no recovery is observed after burn-in.

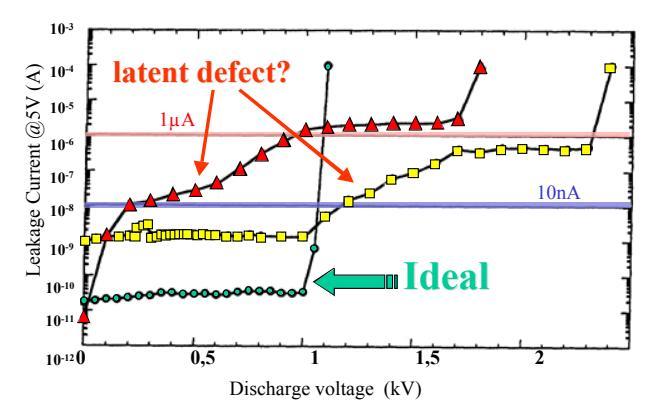
Fig.1: Leakage current of various devices after several ESD stress steps .

ESD qualification usually insures that after a given maximum ESD stress, the circuit is not degraded i.e. functionality and leakage current remain within specifications. As shown in Fig.1, several cases can occur : an abrupt increase of this characteristics (ideal case) or a progressive evolution with stress. Even if a low increase in leakage current is acceptable, its evolution demonstrates the presence of a degradation within the circuit that could develop into a latent defect. Such a defect may evolve during circuit operation and later on result in a field failure.

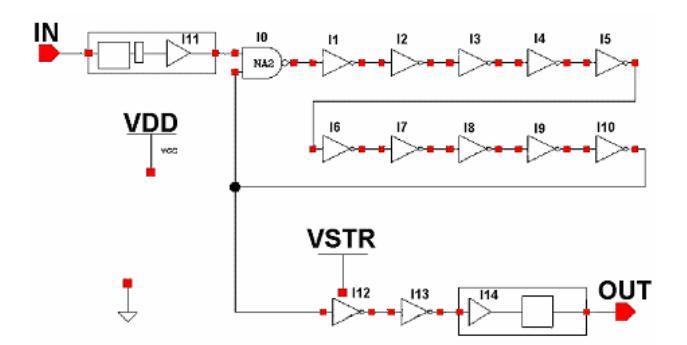
Fig.2: Electrical schematic of the oscillator circuit. VSTR pin is used to apply the ESD stress on inverter I12.

- An oscillator that is controlled by a NAND or a NOR input gate (Fig.2). As a result, depending on the IN input signal, this circuit is either an oscillator (IN=1) or an inverter circuit (IN=0). This allows a simple testing set up for both DC and dynamic electrical measurement.
- A simple analog CMOS differential stage (Fig.3).

The first version of the oscillator under test was the one of Fig.2 having the VSTR pad on one core inverter (I12). The results are presented in Table 1.

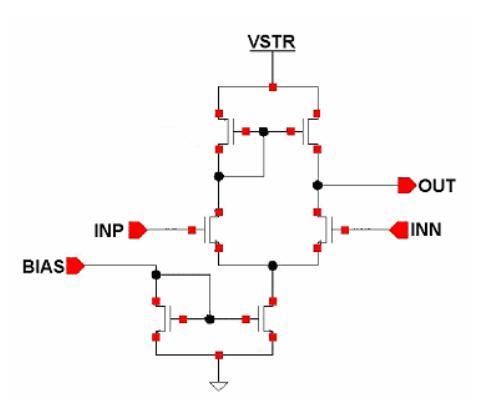
Fig.3 : Electrical schematic of the analog differential stage.

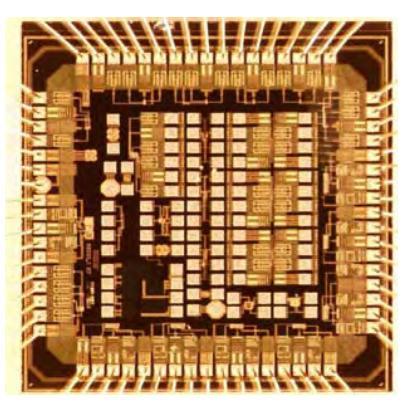
Fig.4 : Optical micrograph of the test chip.

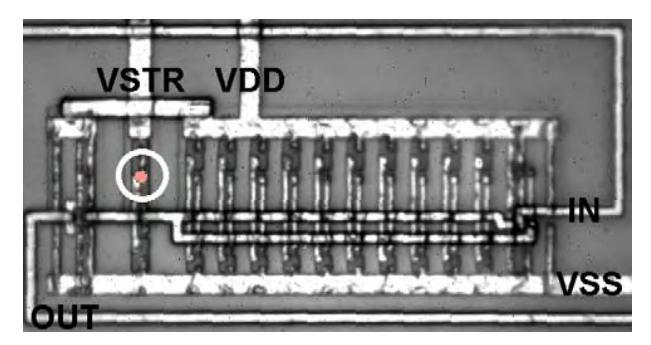
EMMI was able to detect the defect only if the leakage current is in the μ A range. As it can be seen in Fig.5, the emission is located into the PMOS transistor of the stressed logic gate. On this picture, the way the VSTR pad is implemented can be noticed: the stressed inverter has separated N-well and connection to the power supply.

Fig.5: EMMI defect localization (circled) in the oscillator of Fig.2 for sample #5.

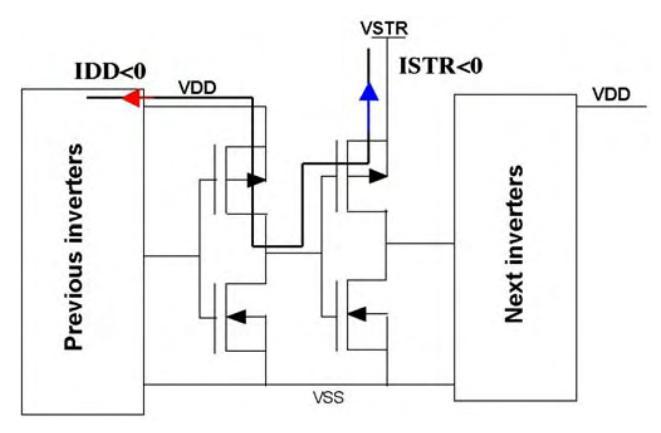
Fig.6: Electrical measurement set-up used for defect localization in the oscillator of Fig.2. Current leakage path for sample #3.

As an example, for the oscillator of Fig.2, the stressed logic gate is the first inverter (I12) of a buffer stage. For DC measurement, we set the input IN of the oscillator to "0", therefore the input of the stressed gate should be high whereas its output should be low. The measurement procedure is the following: VSTR voltage is set to a constant value, here 5V, and VDD voltage is varied from 3 to 5V and vice-versa. For

each VDD (or VSTR) value, the respective leakage currents IDD and ISTR are measured. By analyzing the way these currents evolve, the type of defect can be identified. In most of the cases, the damage is located into the gate oxide of the PMOS transistor of the stressed cell on the source side that is in good agreement with a CDM failure signature [3]. At higher leakage current level (samples #5 and 10 in Table 1), we could also observe a drain-substrate short.

transistors is the normal emission of the transistors in saturation mode. The electrical measurement via the VSTR pad confirmed that the leakage is induced by a gate oxide breakdown between the gate and the source or/and the N-well substrate (Fig.6).

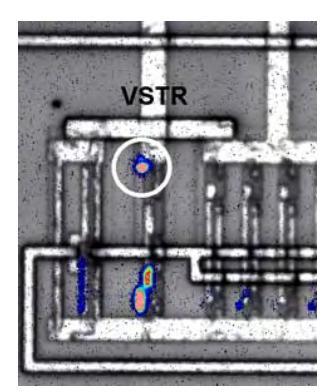
Fig.7: Dynamic EMMI defect localization (circled) in the oscillator of Fig.2 for sample #3.

The only technique able to detect a defect for this particular case, is the dynamic EMMI i.e. during the operation in oscillator mode. It shows that a defect is located in the source side of the PMOS transistor of the stressed gate (Fig.7). The emission in the NMOS

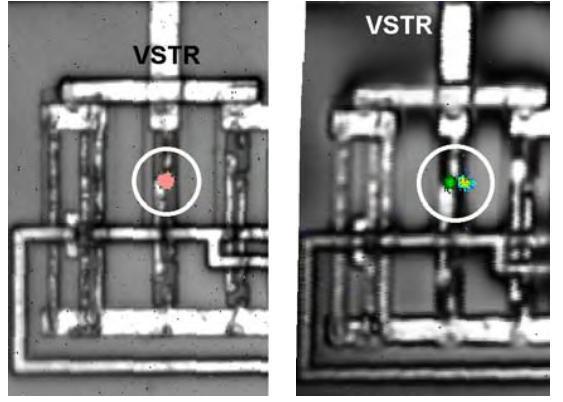
Regarding samples # 5 and 6, both of them exhibit the same defect into the PMOS transistor of the stressed gate that is detected either by EMMI or OBIRCH techniques (Fig.8). The detection via OBIRCH indicates that the defect has a resistive nature. The electrical measurement via the VSTR pad confirmed that the detected short-circuit is a drain to N-well PMOS substrate one. The electrical measurement also allowed the detection of a supplementary leakage path between the gate and the substrate/source of the PMOS transistor.

The observed failure signatures at high and low stress level allows assuming that in both cases, upon the rapid CDM transient, the PMOS gate oxide breaks down. In any cases, all the charges stored within the chip are flowing on the common VSS rail through the triggering of both the PNP and the NPN bipolar transistors associated to the MOS transistors of the stressed logic gate. The PNP transistor is well known for its poor ESD robustness and its activation resulted in a melt filament across the drain-N-well junction.

Fig.8: EMMI (left) and OBIRCH (right) defect localization in the oscillator of Fig.2 for sample #5.

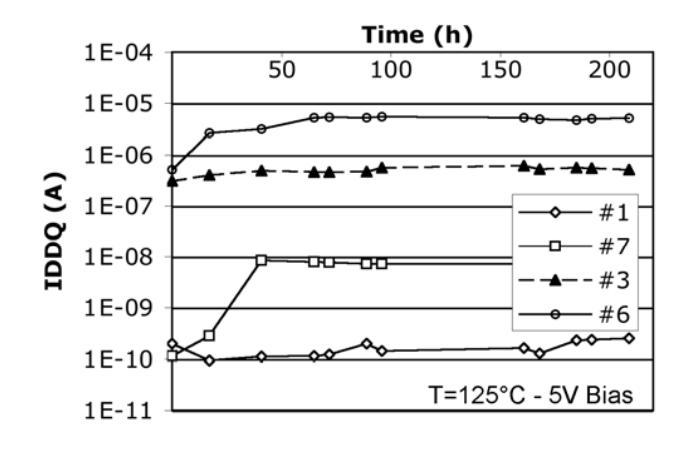
To check the impact of the defect on the long-term reliability of the circuit, we performed a 200h burn-in test, under a 5V bias and 125°C on samples #1, 3, 6 and 7 of the oscillator circuit of Fig.2 (Table 1). The functionality of all the circuits under test was not affected. However, the leakage current of the stressed circuits significantly increased from its original value whereas the leakage current of the reference sample #1 did not evolve (Fig.9). The leakage current of sample #7 increased by 2 decades and the one of sample #6 by one decade. It can be noticed here that the samples exhibiting a significant leakage current increase have both a gate oxide breakdown defect and a melted filament across the drain-Nwell junction of the PMOS transistor as it is the case for sample #6. Sample #3 having only a gate oxide breakdown does not show any increase in current. It can be then concluded that melted filaments across junctions evolve under bias and temperature as expected. These types of defects are therefore likely to reduce the lifetime of a circuit. Nevertheless, at the end of this short accelerated testing, no catastrophic failure was observed.

Fig.9: IDDQ leakage current of samples #1, 3, 6 and 7 of the oscillator of Fig.2 during a 5V biased burn-in test.

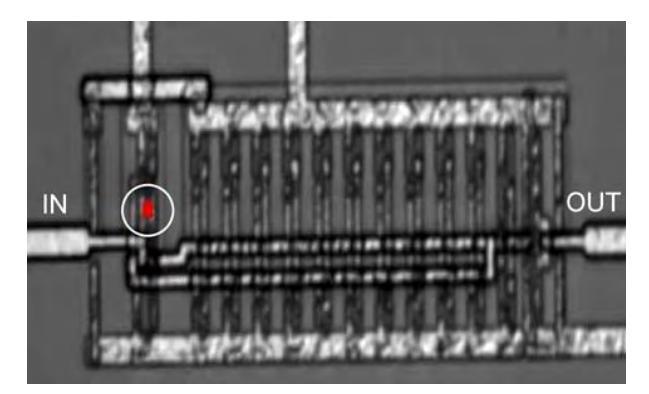
Fig.10: EMMI defect localization (circled) in the oscillator circuit of sample #3 having the VSTR pad on the NAND input gate.

The planned testing procedure of the test vehicle was disturbed by the occurrence of an indirect stress on all the others circuits sharing the common VSS rail except the analog one. The failure location detected through EMMI is always in the PMOS transistor of the logic gate connected to the VSTR pad. The failure mechanism is related to the elimination of the charges stored on the VSTR pin capacitance. Most of the charges stored within the chip are flowing through the ESD protection network of each test circuit (power clamp and I/O protections) and then through the common VSS ra l. The VSTR pins are not connected to any ESD protection network since they are directly connected to the source of the PMOS transistor of the stressed logic gate. Therefore, the only possible discharge path for these charges is through the common VSS ra l after the triggering of the parasitic bipolar transistors associated to the logic gate. Upon the zapping of the VSTR pin, the common VSS ra l is rapidly clamped to a low voltage value by the triggering of the bipolar transistors of the intentionally stressed logic gate. As a result, the charges of the VSTR pins of the non-stressed gates are evacuated through the forward biasing of its related NMOS drain-substrate diode and the triggering of its related PNP transistor. Therefore, the same failure signature as that in the stressed logic gate is also found on the PMOS transistor of the non-stressed logic gate as shown in Fig.10.

The analog circuits are probably not affected because of the much larger size of the involved PMOS transistors. To avoid such secondary stresses in this particular case, a solution would have been to implement a separated VSS pad for each test circuit.
